Electronmicroscopic Study of Sand Erosion Processes in Metals

Grant Number AFOSR-78-3580

Israel Institute of Metals
Technion - Israel Institute of Technology
Haifa, Israel

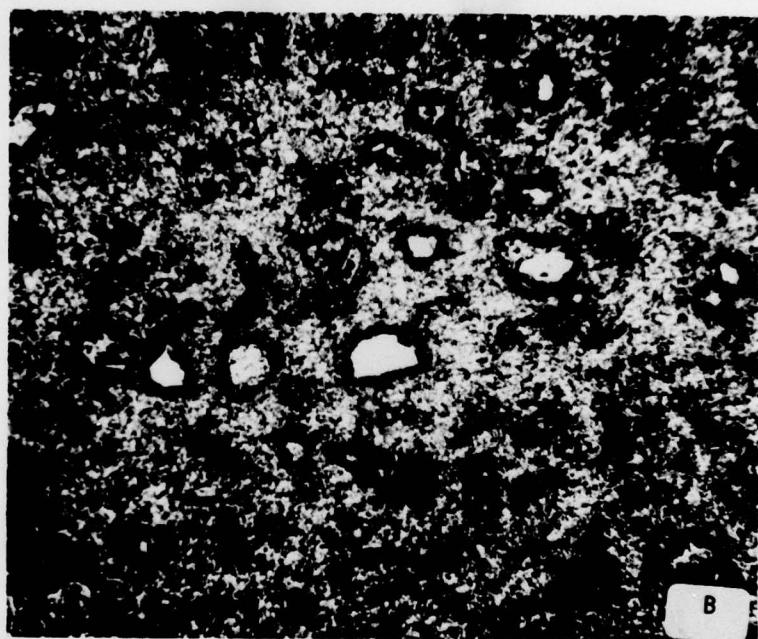
Fig. 6; Optical micrographs of composite aluminium alloy specimens containing 30% Vol. silicon carbide particles

- A. Surface appearance before erosion
- B. Surface appearance after being eroded by 50 gr. sand particles at impact angle of 30° .
- C. Surface appearance after being eroded by 500 gr. sand particles at impact angle of 90° .

Optical Microscopy - A typical general appearance of composite aluminium alloy containing silicon carbide particles as observed with optical microscope is shown in Fig. 6. Before being exposed to erosion conditions the surface contained uniformly distributed silicon carbide particles 100 to 150 microns in size with angular shape as can be seen in Fig. 6A. The particles appear in the photographs (Fig. 6) as bright zones surrounded by dark rim. After erosion many of the hard silicon particles were removed leaving craters and grooves on target surface (dark zones in the photograph, Fig. 6). Removal of hard phase particles from eroded target surface was found at low impact angle (30° see Fig. 6B) as well as at normal angle (90° , Fig. 6C). Careful examination of the eroded surface revealed that some of the grooves or craters (dark areas in the photograph, Fig. 6) contain pieces or fragments of hard phase particles (bright spot areas within the dark zones) which might suggest that particle removal was associated with breaking or fracturing of the hard brittle particles. Detailed observations of target surface were conducted by making use of electron microscopy, and the results obtained are described herein.

The high rate of erosion measured in the composite aluminium alloys compared to non-composite aluminium alloys can be explained by assuming that sand erosion process in the composite alloys is composed of two processes: a) removal of material from the matrix free particle surface; b) removal of hard phase particles completely from the surface (Fig. 6).

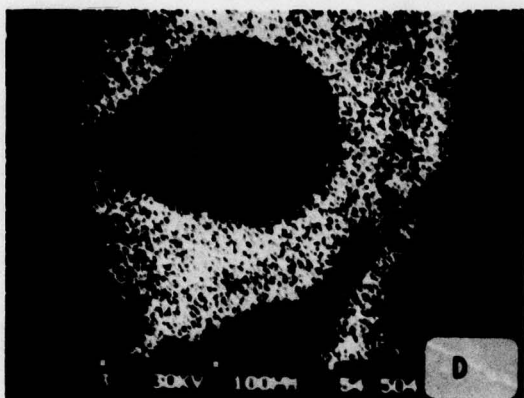
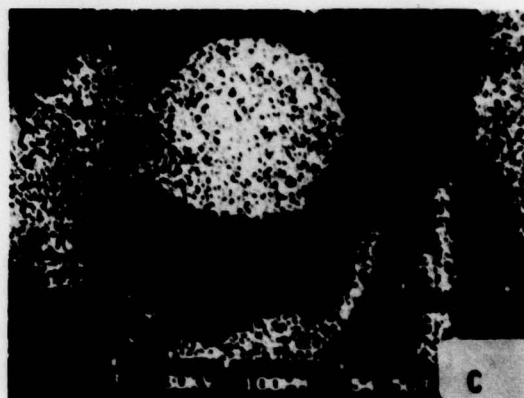
Fig. 7: Composite aluminium alloy containing 40-50% Vol. silicon carbide particles before and after being exposed to 500 gr. sand particles at 30° impact angle. SEM examinations

- A. Target surface before erosion showing the distribution size and concentration of silicon carbide particles.
- B. Same area as in Fig. 7A showing one particle.
- C. X-ray image of Si(K α) showing the distribution of Si in 7B.
- D. X-ray image of Al(K α) showing the distribution of Al in 7B.
- E. General appearance of target surface after being exposed to erosion conditions surface is characterized by cell or cratered type structure together with hard phase particles of silicon carbides.
- F. Enlargement of the area shown in E. It reveals a single hard phase particle.
- G. X-ray image of Si(K α) in the area shown in F.
- H. X-ray image of Al(K α) in the area shown in F.

Surface morphology of composite aluminium alloys containing silicon carbides and alumina before being exposed to various erosion conditions is shown in Fig. 7 (a to c) and in Fig. 11 (a, b) respectively.

ized by the presence of hard phase particles some of which are fully embedded in the surface, some are protruding at various angles from the surface and some are not at the surface any more, leaving craters at their traces (Fig. 7a). A typical silicon carbide particle, its shape and the way it is embedded in the target surface, as well as the interface between the particle and target matrix, is shown in Fig. 7b. X-ray pictures of Figs. 7c and 7d show the presence of Si($K\alpha$) and Al($K\alpha$) in the area shown in Fig. 7b.

After erosion all the composite aluminium alloys containing either silicon carbide or alumina particles exhibited a cratered structure independent of impact angle as shown in Figs. 7-10 for silicon carbide and in Figs. 11, 12 for alumina particles.

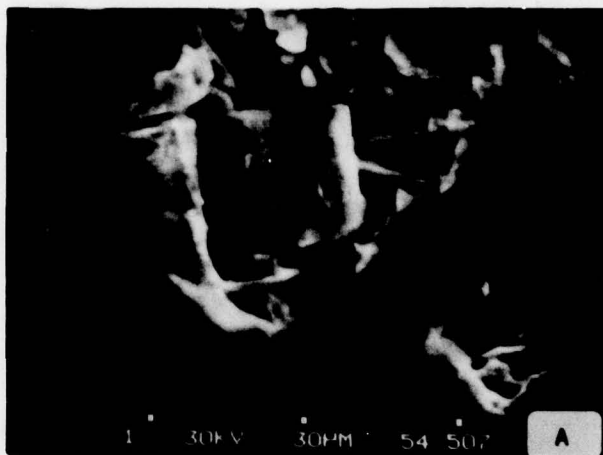
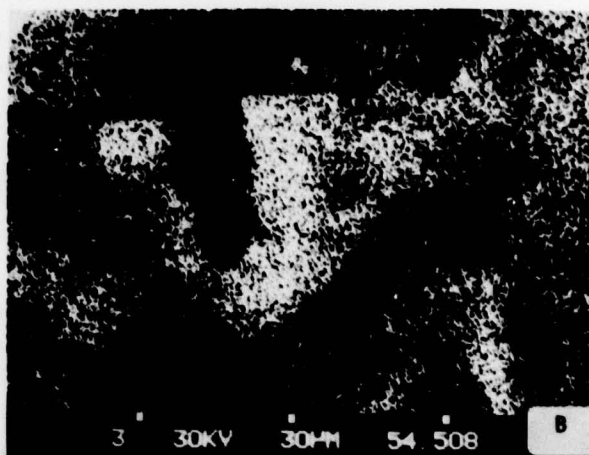
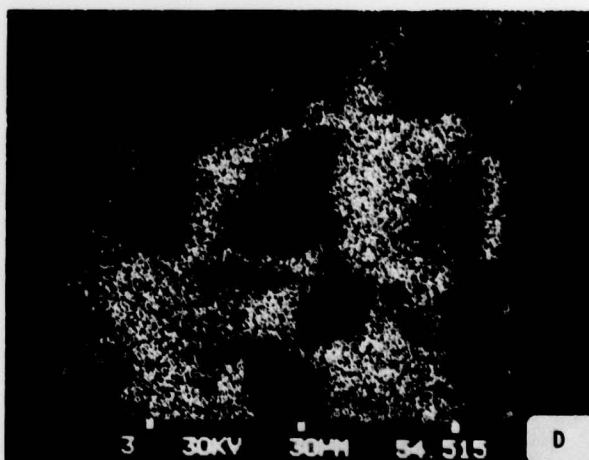
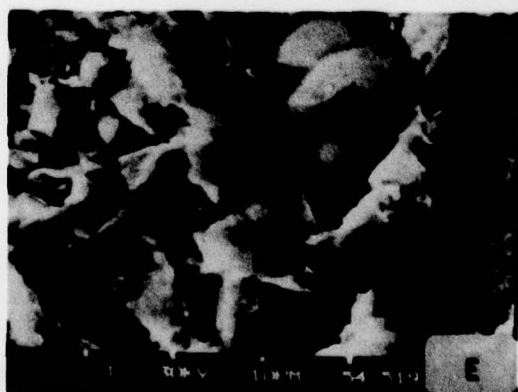
Fig. 8: Appearance of composite aluminium alloy containing 40-50% Vol. silicon carbide particles after being exposed to 500 gr. sand particles at various impact angles.

- A. Eroded surface at impact angle of 30° , showing removal of silicon carbide particle from the surface.
- B. X-ray image of Si($K\alpha$) in the area shown in A.
- C. Eroded surface at normal impact angle showing the removal of silicon carbide particle from the surface.
- D. X-ray image of Si($K\alpha$) in the area shown in C.
- E. Eroded surface at normal impact angle showing the embedding of fragment of sand particle in the eroded surface.
- F. X-ray image of Si(K) in the area shown in E.

Upon exposing target surface to various erosion conditions some of the hard phase particles were removed completely from the surface (Fig. 8). The removal of the particle was associated with its breaking up or fracturing as shown in Figs. 8a-8d. Removal of the hard phase particles resulted in high weight loss or high erosion compared to non-composite alloy exposed under the same erosion condition as shown in Fig. 4.

Local material removal was associated with breaking up of abrasive particles upon striking the surface and thereafter penetration of abrasive fragments into the surface, Figs. 8e and 8f. This was observed previously in ductile non-composite alloys of aluminium⁽¹⁰⁾.

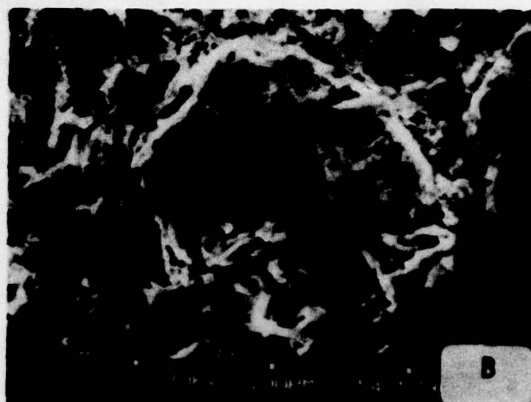
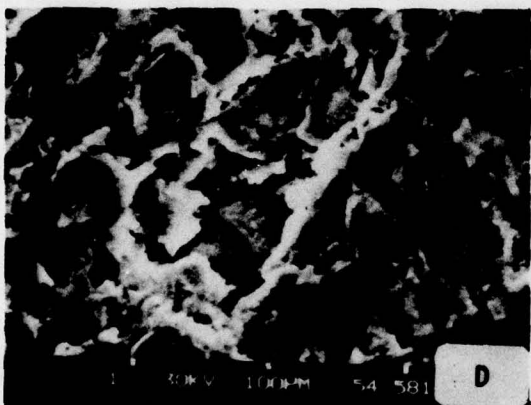
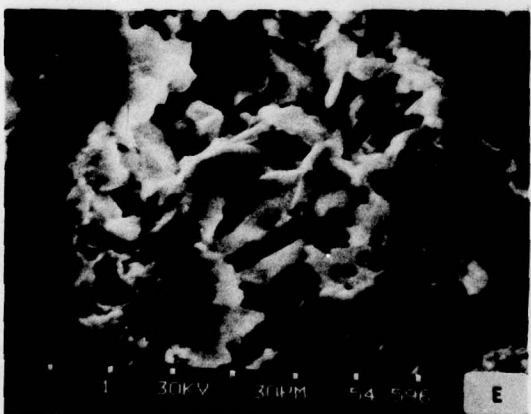
Fig. 9: Appearance of composite aluminium alloy containing 30% Vol. silicon carbide particles after being exposed to 500 gr. abrasive sand particles at various impact angles. SEM examinations

- A. General view of eroded surface at impact angle of 30° . Cratered structure and particles are shown.
- B. Enlargement of the area shown in A. A single eroded particle is shown.
- C. X-ray image of Si(K α) in the area shown in B.
- D. Removal of material resulted in exposing a silicon carbide particle beneath the surface.
- E. Removal of silicon carbide particle from a target surface exposed to impact angle of 60° .
- F. X-ray image of Si(K α) in the area shown in E.
- G. Removal of silicon carbide particle from a target surface exposed to impact angle of 90° .
- H. X-ray image of Si(K α) in the area shown in G.

The general cratered structure of eroded surfaces was the result of many localized material removal processes occurring when the metal surface was struck by the abrasive particles⁽¹⁰⁾. Localized material removal processes at free particle surface area resulted in cratered type structure in all the alloys examined. However, when abrasive sand struck directly on hard particle in the target surface no material removal or cratered structure was detected in the particle as can be seen in Figs. 9 and 10.

Furthermore when a particle was embedded just below the target surface it stopped the continuation of local material removal upon exposing the particle surface (Figs. 9, 10).

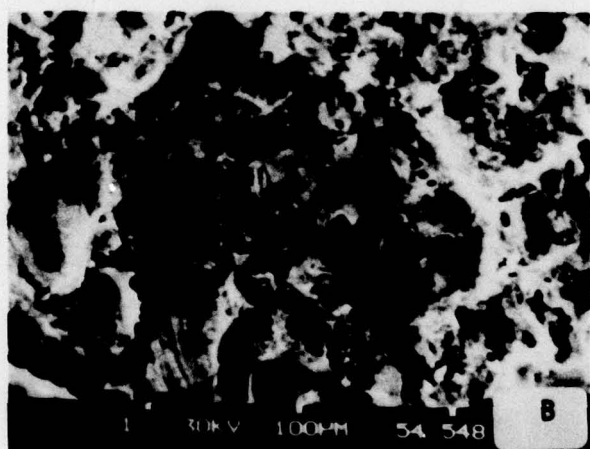
Fig. 10: Eroded surface appearance after being exposed to 500 gr. abrasive sand particle at impact angle of 30° . SEM examinations.

- A. General view of eroded surface. Cell type or cratered structure together with particles are shown.
- B. A typical single hard phase particle in the eroded area shown in A. Particle surfaces do not erode in the same way as the matrix.
- C. X-ray image of Si(K α) in the area shown in B indicating that the particle is actually SiC.
- D. Removal of a hard phase silicon carbide particle from eroded surface which resulted in a fractured area.
- E. Si(K α) X-ray image showing the distribution of Si in area D indicating the presence of SiC.
- F. Al(K α) X-ray image for distribution of Al in area D.

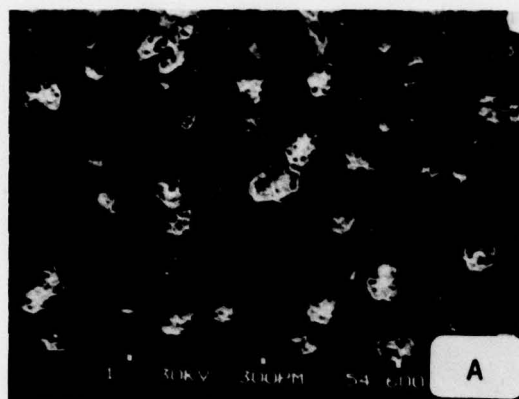
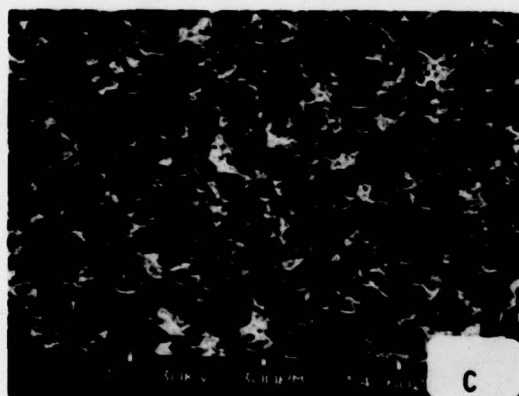
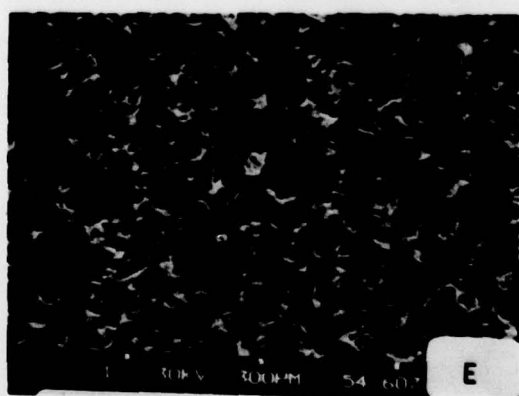
Fig. 11: Surface view of composite aluminium alloy containing 30% Vol. alumina particles before and after being exposed to erosion. SEM micrographs.

- A. General appearance of target surface showing presence and distribution of alumina particles before erosion.
- B. A typical alumina particle in the surface before erosion. It is noted that the alumina particles tend to agglomerate in local zones as shown also in A.
- C. After erosion - presence of alumina particles in eroded surface exhibiting cell type or cratered structure. Target was subjected to 500 gr. sand particles at 30° impingement angle.
- D. High magnification view of area shown in C. Material removal and erosion process are shown around alumina particles.
- E. After erosion - view of eroded target surface after being exposed to 500 gr. sand particles at 60° impact angle. Presence of alumina particles within eroded cratered surface structure.
- F. A typical view of erosion process or material removal in the vicinity of alumina particles in the eroded surface.

Scanning Electron Microscopy - The general appearance of the surfaces as observed with the scanning electron microscope is shown in Figs. 7 to 10 for composite aluminium alloy containing silicon carbide particles and in Figs. 11, 12 for alumina particles.

Examination of eroded surface of aluminium alloy containing alumina particles showed that local material removal occurred around the particles (Figs. 11, 12) where the particles themselves were removed thereafter.

b) Removal of hard phase constituents and particles primarily by undermining of the material immediately next to these particles as shown, for example, in Figs. 8, 9 & 11. Removal of these particles from the surface resulted in a fractured surface containing fragments of the hard particle material for instance, silicon carbide as can be seen in Figs. 8a-8d.

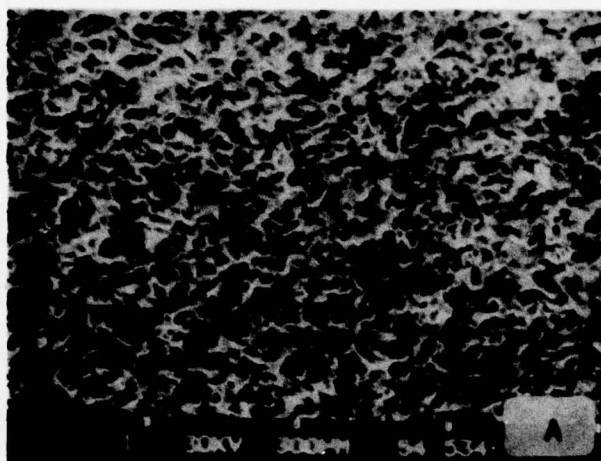
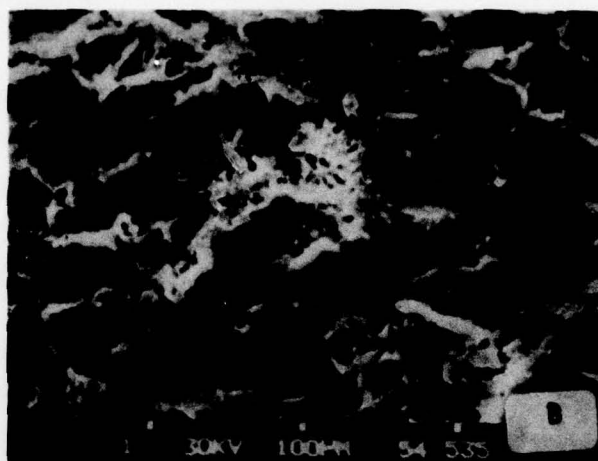
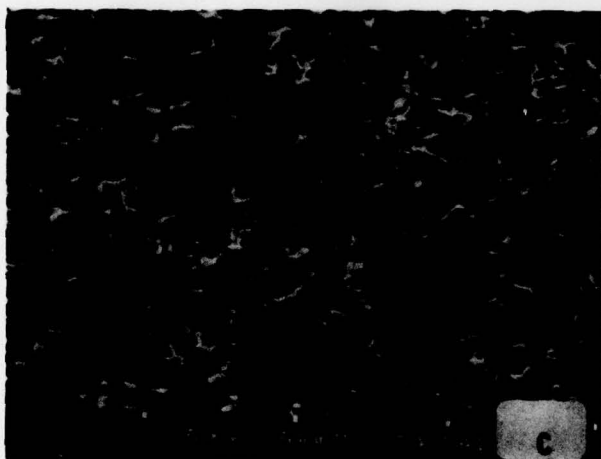
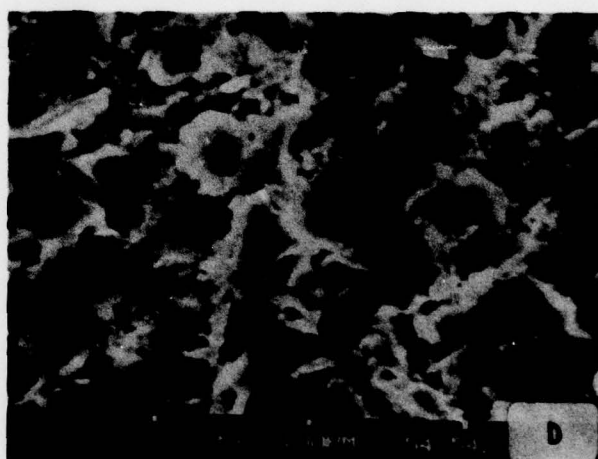
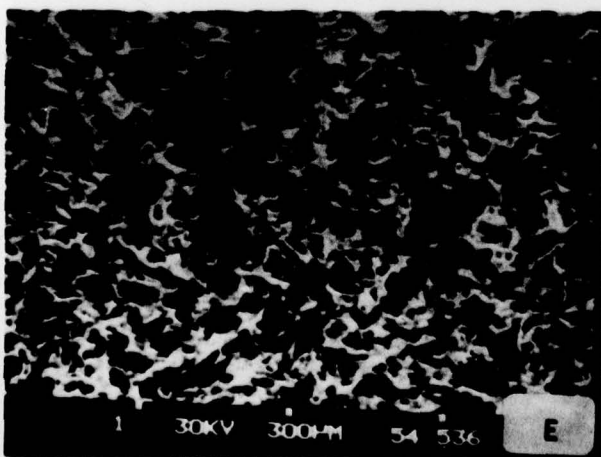
Fig. 12: Eroded surface of composite aluminium alloy containing 15% Vol. alumina particles after being exposed to 500 gr. abrasive sand particles at various impact angles.

- A. Eroded surface impacted at 30° . Cell type structure and some alumina particles are shown.
- B. A typical alumina particle within the eroded area characterized by cell structure. Magnification of the area shown in A.
- C. Eroded surface impacted at 60° resulted in cell type structure. Also some alumina particles are shown within the eroded surface.
- D. Detailed eroded surface structure of the area shown in C.
- E. Eroded surface impacted at 90° resulted in cell type structure which is characteristic also of non-composite alloys.
- F. Detailed structure of the eroded area shown in Fig. E.
